Rehabilitation and Repair of Al-Khariaji Mansion Located in Al-Medinah, Saudi Arabia.

Tarek. M. Al-Hussain¹, Abdulrahman Marei², Hussain Alshkffa³, Badr
Alraddadi⁴, Mohammed laissy⁵.

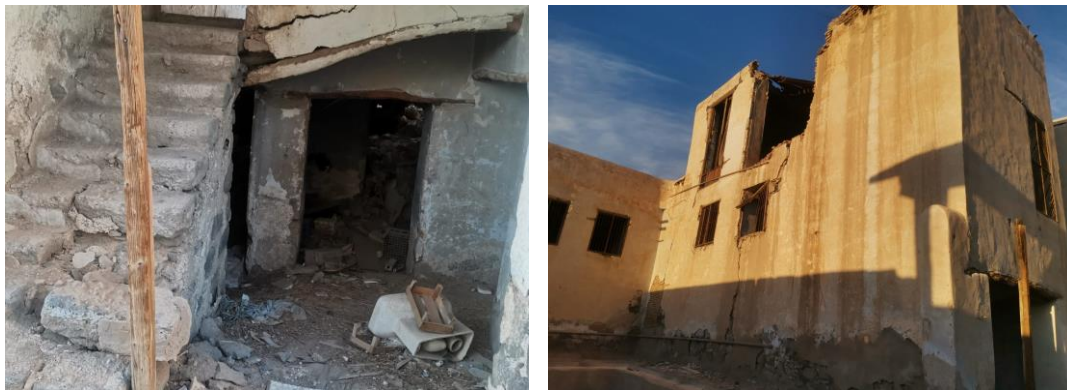
Figure 2: Cracks

The most common solutions for structural cracks are Epoxy Injection, Polyurethane Injection, and Stitching. Epoxy injection is known for its high strength and long lifetime, but it is the most expensive and difficult to adapt. On the other hand, Polyurethane injection is less expensive and easier to adapt to but achieves lower strength. Stitching cracks is comparatively less expensive and has a shorter lifetime, but it is difficult to adapt. The cost of Epoxy injection is around 950\$- including labor charges, and its lifetime is around 7 to 10 years. The cost of Polyurethane injection is around 740\$- including labor charges, and its lifetime is around 5 to 6 years. The cost of Stitching cracks is around \$740, and its lifetime is around 3 to 4 years. Among these

solutions, Epoxy Injection is the most suitable for structural crack repair, especially for heritage buildings, because of its high strength and long lifetime.

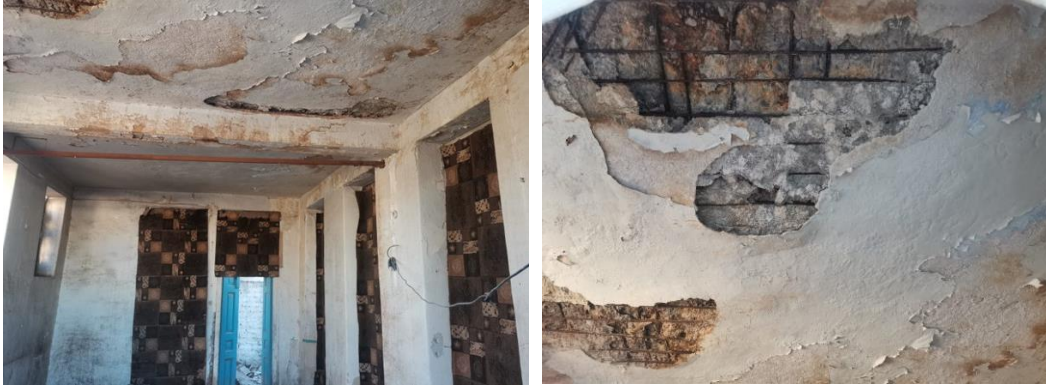
Figure 3: Roof Leakage & Mold Stains

Heritage buildings frequently experience roof leaks, and the most common fixes involve replacing the broken clay roof tiles with new ones and rearranging the sealant. Clay roof tiles are about 40\$ per square foot, sealer is about 14 British Pounds each kilogram lime mortar is about 10 British Pounds for 20 kilograms. Asbestos roof and refill sealant are used to replace damaged roof areas with lead flashing. A clay roof tile lasts roughly 75 years, and the implementation cost is around 600\$. Asbestos roof damage is repaired with lead flashing and sealant replacement.

The cost of implementation is around 600\$ and the lifetime of a lead flashing is about 75 years. The most important details in this text are the cost of asbestos sealant, lead flashing sheet, primer flashing strip and primer solution. The cost of asbestos sealant is 10 British Pounds per Kg, while lead flashing sheet is 30 British Pounds per square foot, primer flashing strip is 5 British Pounds per square foot, and primer solution is 2 British Pounds per Kg. Lead flashing is the best suited and effective solution for leakages of roof, as yielded lifetime of the solution is most considered in heritage buildings.

Mold stains are a common issue with historical structures. Applying soap water under high pressure is the best remedy for this specific issue. Pressure nozzle, pressure controller, and tube are the materials needed for this issue. The price of the kit is approximately 40\$ practice is \$20. The approach will cost 20+40=60\$ approximately in total. This solution will have a life expectancy of about 5 to 6 years.

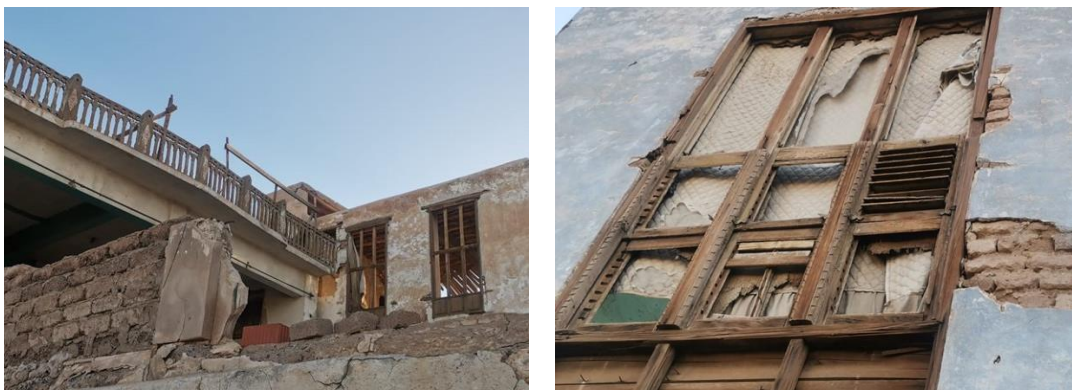
Figure 4: Peeling of Walls & Ceiling

Peeling of the walls and ceilings is another significant flaw found in historic houses. The best and most efficient remedy for plaster or wall flaking is Mughal plastering, which is little more than lime mortar plastering. As of April 6, 2016, the price of lime mortar will range between 10 British Pounds or 940/- per 20Kg. The implementation fee will be about \$360. As a result, the total cost of the method will be roughly 360\$. The lifespan of Mughal plastering is ten years or so. Due to its great finishing and attractive condition, Mughal plastering is also regarded as an efficient remedy.

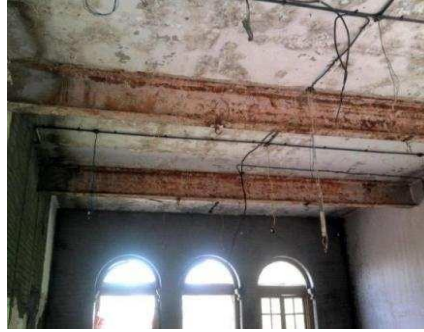
Based on Sayali Sandbhor, et al presented a proposal for Repair and Rehabilitation work on a building constructed during the British period in 1871. The authors identified several issues, including structural cracks in masonry walls, cracks in the lime concrete slab, collapse of column portions, and roof leakages. These problems were caused by poor load distribution, inadequate waterproofing, seepage of water, and waterlogging [1]. C. Natarajan, et al documented their Rehabilitation work on St. Lourdes Church in Tiruchirapalli, which was originally constructed in 1890. During their project, the authors encountered several issues, including mold stains and water damage, cracks in the outer brick surface, decay of bricks in the inner surface, and erosion on the roof surface. These issues were caused by poor waterproofing, seepage of water, and water logging [2].

Figure 14 Roof leakage [1]

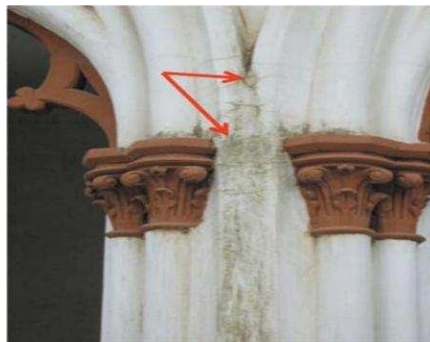
Subsequent to Natarajan's work, Suresh Chandra Pattanaik, et al conducted their Repair and Rehabilitation project on an institutional building situated in Mangalore, which was constructed 75 years ago. The team identified several issues, including spalled plaster, fungus growth on walls, cracks in the ceiling and masonry walls, as well as corrosion and spalling of concrete in columns. These issues were primarily caused by severe water leakages and environmental distress [3].

Figure 15 mold stains as the arrows showed.

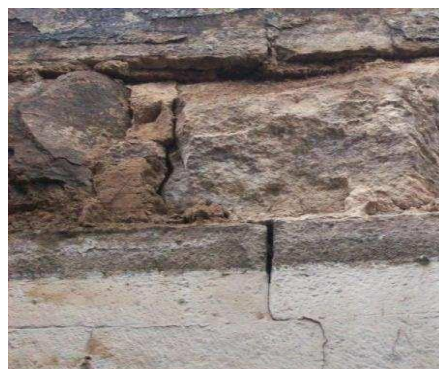
In 2017, Gaby Ruiz Petrozzi, et al presented their rehabilitation work on a century-old adobe church called Santisma Cruz Del Norte situated in the heart of metropolitan Piura, which was constructed in 1917. The authors identified several issues, including cracks at the corners of the walls and across the back wall, cracks between an RC choir loft and the adobe walls, eroded blocks, and cracks at the roof level. These problems were mainly caused by moisture seepage [4]. In addition, Nur Liyana Othman et al conducted a case study on the Sultanah Bahiyah hospital building located in Alor Setar. They identified several issues such as leakages at ceilings and watermarks, black staining in walls and dampness, and corrosion at the roof gutter. These issues were caused by rainwater entering through louvers due to the shortness of the awning, water seepage from the toilet area, and environmental factors [5].

Figure 16 Vertical Cracks and Gaps.
