Geophysical Investigation of Causes of Road Failure along Abadina Community Road, University Of Ibadan, Nigeria.

Aderemi F. L.. and Adeola R.O.

Department of Physics, University of Ibadan, Ibadan, Oyo State, Nigeria

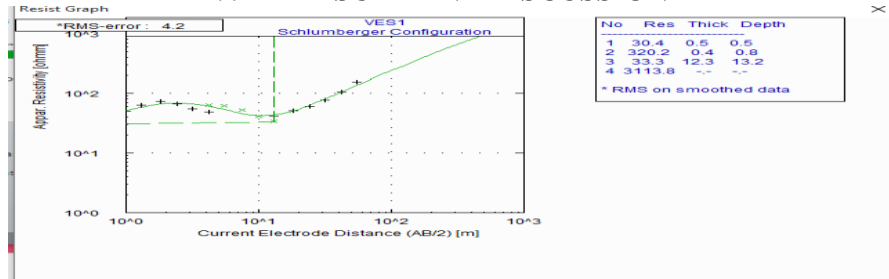
Figure 3: Interpreted Schlumberger depth sounding curve for VES 1.

VES 1 of KH curve type is located at latitude 7°27'06.40"N and longitude 3°53'93.50"E with four geo-electric layers. The first geo-electric layer is composed of topsoil with resistivity values of 30.4 Ω m and thickness of 0.5m. The second geo-electric layer is composed of sandy clay with resistivity values of 320.2 Ω m and thickness 0.4m and depth of 0.9m. The third geo-electric layer is composed of saturated sandy clay with resistivity of 33.3 Ω m and thickness of 12.3m and depth of 13.2m. The fourth geo-electric layer is composed of the weathered fractured basement layer with resistivity value 3113.8 Ω m. The curve type of VES 2 is KH and it is located at latitude 7°27'04.30"N and longitude 3°53'93.80"E with four geo-electric layers. The first geo-electric layer is composed of topsoil with resistivity values of 276.8 Ω m and thickness of 0.6m. The second geo-electric layer is composed of sandy clay with resistivity values of 103.5 Ω m and thickness 2.9m and depth of 3.5m. The third geo-electric layer is composed of saturated sandy clay with resistivity of 19.8 Ω m and thickness of 6.2m and depth of 9.6m. The fourth geo-electric layer is composed of the weathered fractured basement layer with resistivity value 815 Ω m. The curve type of VES 3 is H located at latitude 7°27'04.10"N and longitude
