Structural Assessment of the Archaeological Areas in Al-Madinah Region: A Case Study of Al-Tawbah Mosque

ABSTRACT: This research assesses the structural status of historical sites in the Al-Madinah region, with a focus on the Al-Tawbah Mosque as a case study. The goal of this project is to examine the preservation and repair needs of historic sites through engineering analysis and community participation. The research technique includes field surveys, data collection, and engineering analysis. Field studies describe the current condition of historical sites, noting structural integrity, deterioration regions, and causes that contribute to degradation. Data collection comprises accumulating historical information, architectural blueprints, and previous research works in order to comprehend the original design, building techniques, and historical relevance. Non-destructive testing processes are used in engineering studies to evaluate structure stability, material condition, and potential hazards. The findings show the current state of the historical site, highlighting specific issues such as deterioration and fragility. The team will study the mosque's structural integrity, detect d

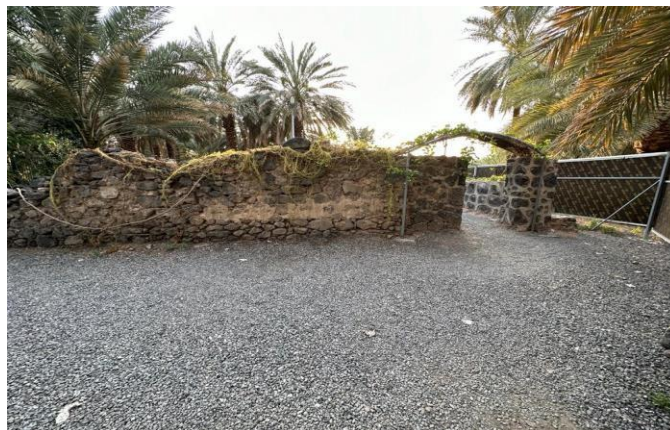
Figure1: The Last Rehabilitation phase for Al-Tawbah Mosque

- This mosque was rehabilitated by the Calipha Omar bin Abdul-Aziz, when he was over the emirate of Al-Medina between the years 87 and 93 AH.
- The last renovation of the mosque was during the Ottoman empire and was rebuilt and renewed in the form of a wall that has a height approximately of 2 m as shown in figure 1 which, only preserved the position of the mosque.

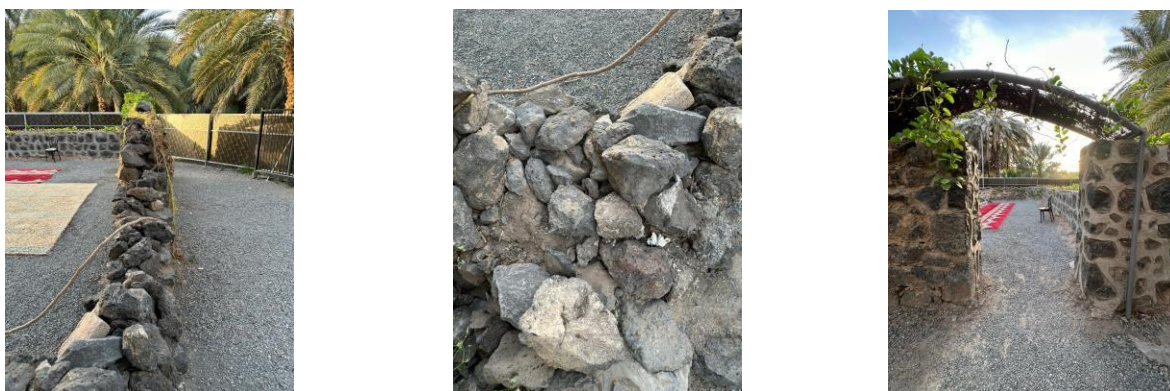
Figure4: Preliminary investigation for Al-Tawbah Mosque

The preliminary investigation contributes to understanding the previous record of the structure as well as assessing the building's apparent physical condition and assessing the building's strength and safety. The preliminary investigation is divided into two main parts which are reviewing the building record and the condition survey. While the detailed investigation is requested in the absence of sufficient data of the studied case, such as the original building drawings and the design of the structure. However, it requires more time and devices. In this report we will focus more on the preliminary investigation.

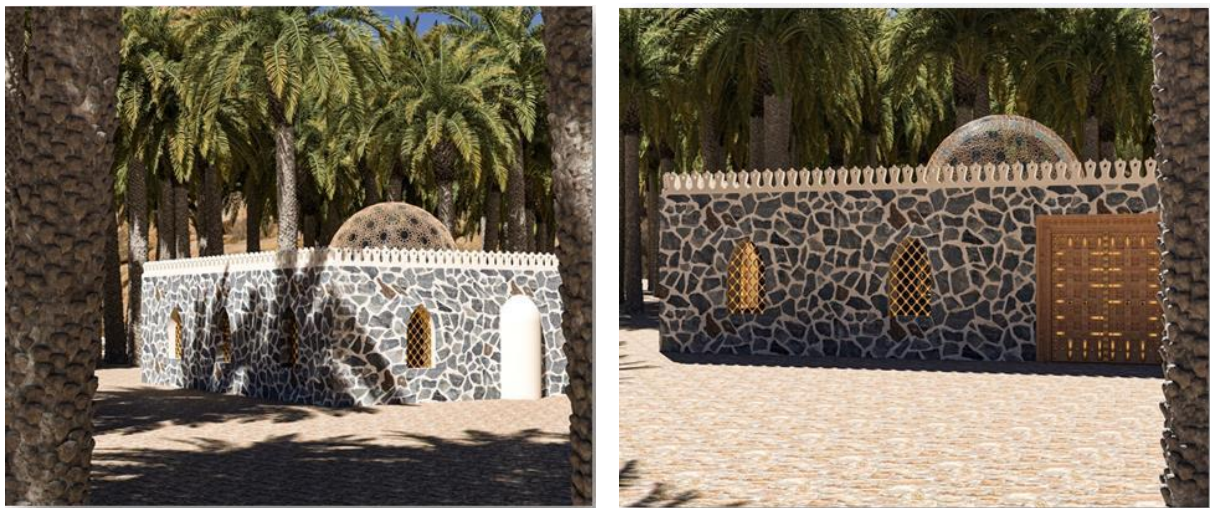
Figure8: Represent the 3D Model of Al-Tawbah Mosque

In order to safeguard the continuity of cultural traditions and practices for future generations, it is crucial to preserve this heritage site. The mosque's cultural continuity and authenticity are increased by the renovation project's incorporation of regional materials including basalt rock and palm wood. By include them in the project, we honor regional construction customs and make sure that the renovated mosque accurately represents the region's unique architectural legacy. Local materials can efficiently integrate in with the Al-Tawbah Mosque's original architectural features. They create a harmonious and appealing look by blending in with the surroundings with their colors, textures, and natural beauty. By utilizing these materials, the rehabilitated mosque is made blend in seamlessly with its past context and architectural design, improving the site's overall aesthetic effect. In addition, as shown in Figure 1, the Dome is made of a wooden material that is covered by reinforced glass. This enables the sunlight to enter, so the prayers and visitors can feel the surrounding environment. Also, the plan was modified to be suitable for visitors. The 3D MAX software and RENO software were used to create 3D model and the model was designed regarding to modified AutoCAD plan.
