Identification of Cultural Heritage Building Characteristics Shirathal Mustaqiem Mosque Samarinda Seberang, Samarinda City

ABSTRACT

The purpose of this study was to determine the characteristics of the building with wood materials in the Shirathal Mustaqiem Mosque cultural heritage building in Samarinda City.

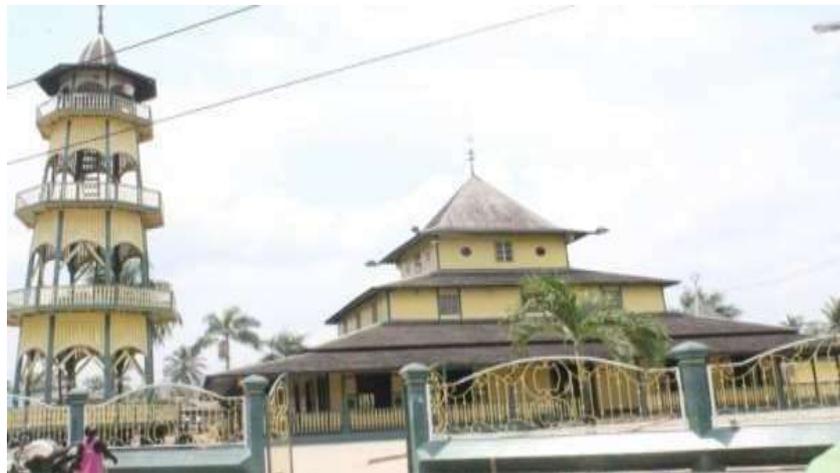
Figure 1. Shirathal Mustaqiem Mosque, Samarinda

The research was carried out from September 2021 to November 2021, where the research location of the Shirathal Mustaqiem Mosque was on the corner of the road, namely on Pangeran Bendahara Street and K.H. Mas Penghulu Street, Mesjid Urban Village, Samarinda Seberang sub District, Samarinda Municipality (Figure 1).

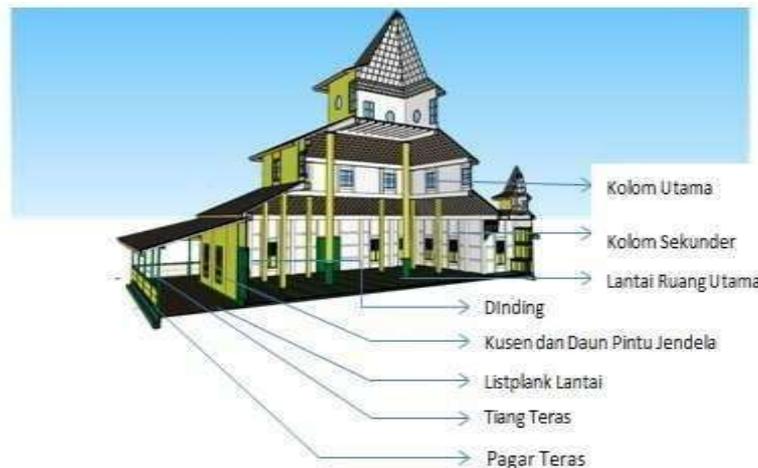
Figure 2. Isometric Model of the Shirathal Mustaqiem Mosque, Samarinda

the area where the mosque was built was given the name "Kampung Mesjid" and is now the village of the Mosque. This mosque was rehabilitated in 2001 by the Mayor of Samarinda Achmad Amins. This mosque is a cultural heritage, which is protected by Law Number 5 of 1992 concerning cultural heritage objects [8]. Until now, the architecture of the mosque, which was completed in 1891, has not changed. Although there is treatment done. Even the second best historic mosque in Indonesia has become a sacred location for local residents [9]. The isometric model of the Shirathal Mustaqiem Mosque, Samarinda and the components that make up the building are presented in Figure 2.

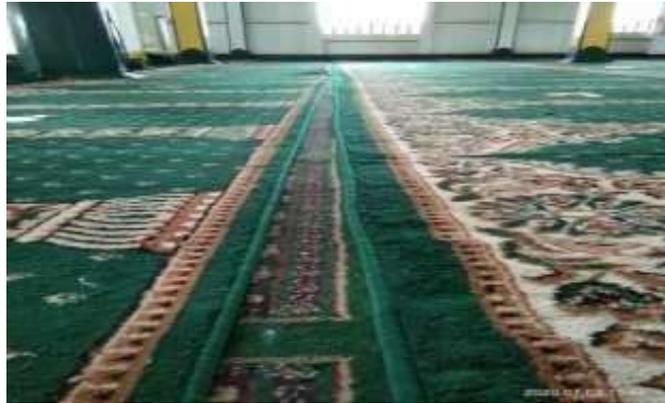
Figure 3. The Condition of the Floor of the Main Room of the Mosque

The main floor of the mosque is covered by two layers of carpet. The first layer of carpet was installed to coat the wooden floor using glue, the second layer of carpet was installed to cover the first carpet and reinforced with nails. The width of the floor boards cannot be measured, because they are covered with carpet. Likewise, the type of connection used, cannot be seen. The floor area of this main room is 440.75 M² (Figure 3).

1. There was a decline in the wooden floor in several places. The biggest drop is in the center of the building between the main columns. However, not all floors have decreased. Some parts are flat and not wavy.

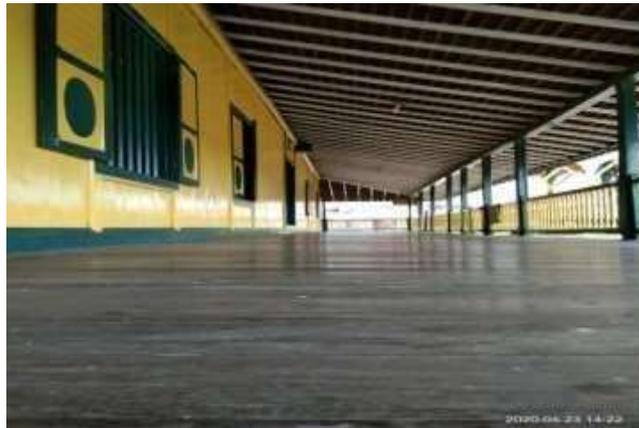
Figure 4. Mosque Terrace Floor

The terrace surrounds the main room of the mosque with an area of 390 M². The terrace floor uses a ± 2 cm thick board and a width that varies between 15-19 cm. The width of the terrace board is 15-19 cm and the thickness is 2 cm. The length of the boards varies from ± 70 cm to ± 340 cm (Figure 4).

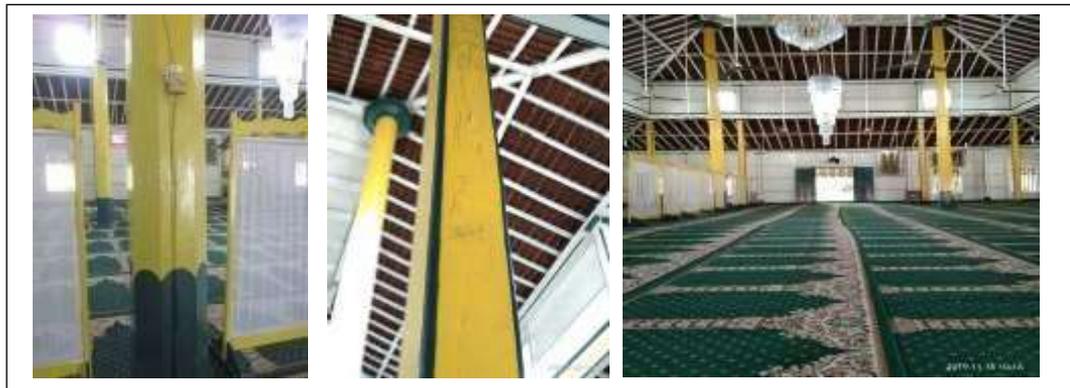
Figure 5. Condition of Main Column and Secondary Column

This mosque building is supported by 4 main columns and 12 secondary columns. These columns support the construction of the roof of the building. The main column consists of 4 octagons and each side has a width of 16–18.5 cm and a height of 8.35 meters from the floor. While the secondary columns are 12 rectangular pieces and each side has dimensions of 23-25 cm and a height of 4.2 meters.

The wood of the existing poles is not perfectly flat, but the rough edges are still visible. The bottom side of the pole is mounted with a 6 cm profile of wood around the pole. Likewise, on the upper side of the pole, profiled wood is also installed, just below the ringbalk beam. Column connection type with beam is not visible. All wood columns are intact without joints. The main pillar looks bigger on the bottom side and gets smaller on the top side of the column. All poles are painted in green and yellow. For the main column, it is painted green as high as 82 cm from the face of the floor and on the top side of the wooden profile, while the rest is painted in yellow. For the secondary column, the bottom side of the green paint is only 30 cm high and the rest is yellow (Figure 5).

2. This mosque building is supported by 4 main columns and 12 secondary columns. These columns support the construction of the roof of the building. The main pillar looks bigger on the bottom side and gets smaller on the top side of the column. All wood columns are intact without joints.

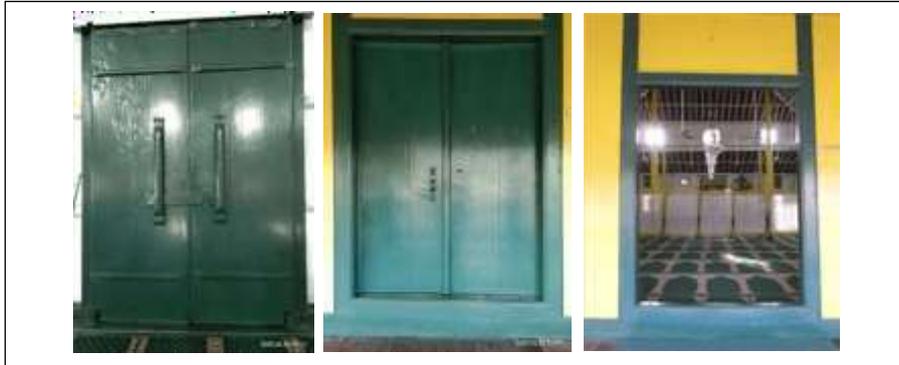
Figure 7. Doors Seen from the Inside and Outside

This mosque has 3 doors as access to the main room. The doors are on the east, north and south sides. Each door has a pair of leaves that open inward. The width of the door is 168 cm and the height is 227 cm. The door is equipped with a frame pole which has a wooden dimension of 17 cm x 17 cm, continuously from the floor to the ringbalk. While the horizontal frame has dimensions of 12 cm x 17 cm wood as the lower threshold and upper threshold. The door of this mosque has a lower threshold and is placed after the floor plank. So the height of the door line is 37 cm from the terrace floor. Every visitor who wants to enter the main room must step over the lintel under the door.

For the room security system, from the inside of the door a wooden barrier is given as a lock which is attached to the handle. The door handle on the inside is also made of wood which is attached using nails to the door leaf. From the inside, each door is equipped with a list of wood across the top and bottom. While from the

outside there is an iron that serves as a place for installing security / locks. The doors are painted dark green on both sides. Each door leaf measuring 90 cm x 227 cm is made of two or 3 pieces of wood and is 5 cm thick. The door leaf uses an "axle" hinge which is a mechanical system for opening and closing movements (Figure 7 and Figure 8).

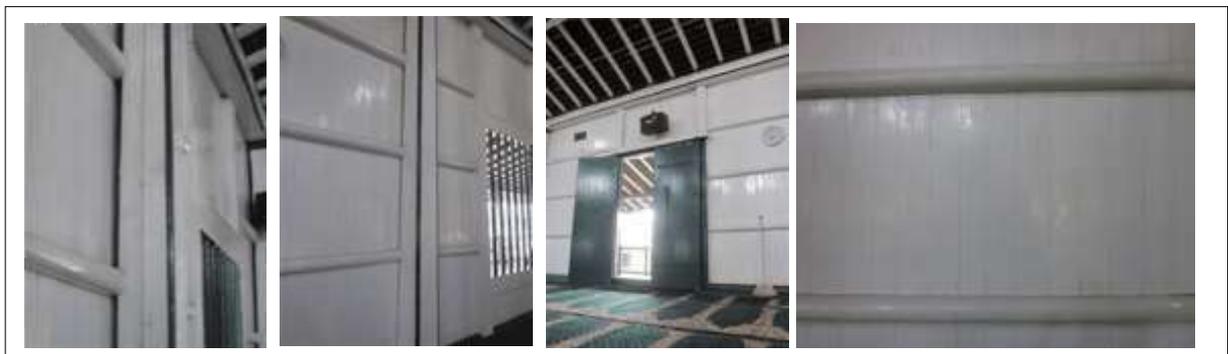
Figure 9. Walls and Wall Beams

The walls of the mosque are boards with a width varying between 9.5-20 cm, a thickness of ± 2 cm and a length of ± 3.34 meters. Mounted vertically with the help of 3 wall beams of semi circular shape with an outline of 20 cm. The distance between the wall beams is 90 cm. These wall beams are installed horizontally and are connected between columns with a distance of 340 cm. The dimensions of this wall column are 23cmx23 cm. The walls are painted white on the inside and yellow on the outside. While the wall columns are painted dark green. On the outer side of the wall, a transverse beam is installed at the top to support the roof rafters (Figure 9).

4. The walls of the mosque are boards with a width varying between 9.5-20 cm, a thickness of ± 2 cm and a length of ± 3.34 meters. Mounted vertically with the help of 3 wall beams of semicircular shape with an outline of 20cm.

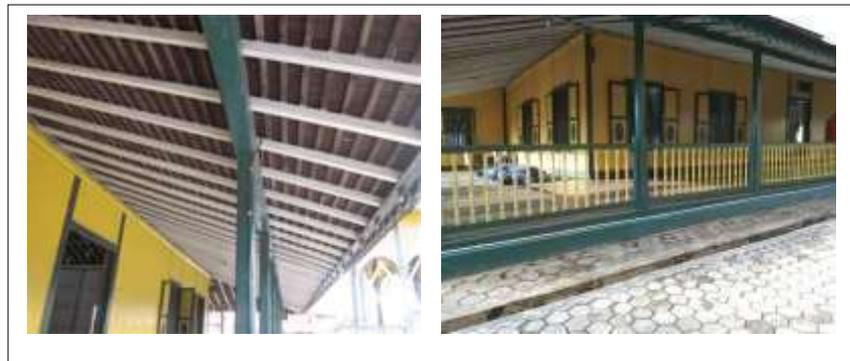
Figure 11.Terrace Poles

The pillars of the terrace are beams with dimensions of 13 cm x 13 cm with a height of 331 cm from the floor, installed around the terrace. The distance between the pillar soft his terrace varies, namely 210, 220, 290, 295, 310, 340, 350 and 400 cm. This terrace pole is not only used as a pillar for the construction of the terrace roof, but also as a place for installing terrace fences. There are 37 terrace pillars in this mosque. The terrace poles are covered with dark green paint (Picture 11).

5. This terrace pole is not only used as a pedestal for the construction of the terrace roof, but also as a place for installing terrace fences. There are 37 terrace pillars in this mosque.

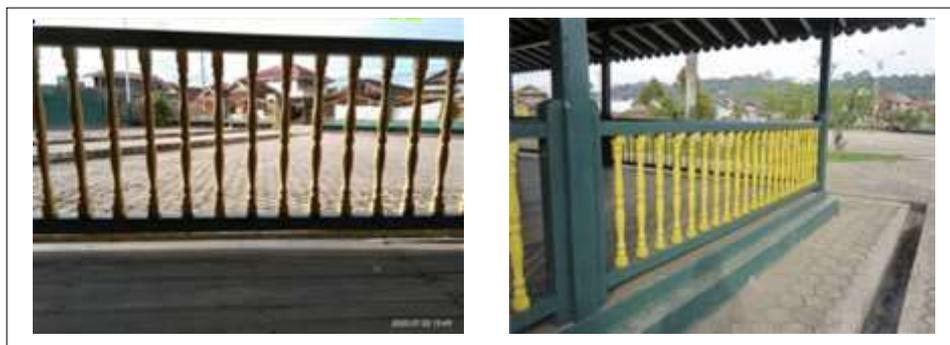
Figure 12.Terrace Fence

The terrace fence is a barrier between the building and the yard, with a height of 90 cm from the face of the floor and is installed between the pillars of the terrace. The length of each fence varies according to the distance of the poles which is also not the same. The fence frame uses a 7 cm x 7 cm beam and the railing is made of 4 cm x 4 cm beam. The distance between the railings is approximately 10 cm, so the number one ach fence varies according to the distance between the terrace columns. This patio fence has 2 small doors and 3 large doors. The small door is on the west side of the building, namely on the left and right sides of the mihrab room. While the 3 large doors as access to the terrace are on the east, north and south sides of the mosque. The large gate has direct access to the main door. The width of the gate is 2.1 meters and has two leaves that use butterfly hinges (Figure 12).

6. The patio fence has 2 small doors and 3 large doors. The small door is on the west side of the building, namely on the left and right sides of the mihrab room. While the 3 large doors as access to the terrace are on the east, north and south sides of the mosque.
