Quest Journals Journal of Architecture and Civil Engineering Volume 9 ~ Issue 10 (2024) pp: 42-59 ISSN(Online): 2321-8193

Restoring the Roots: Structural Integrity and Exceptional Origins of Yusufganj Mosque, Sonargaon, Bangladesh

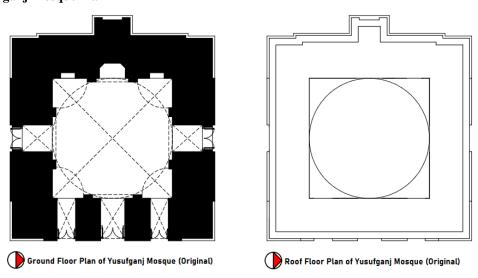
Fig.06 Ground Floor Plan & Roof Floor Plan of Yousufganj Mosque (Origin), Drawing by 1st Author.

From 1200th century, the procession of the Sultanate began. All Islamic architecture since that time has certain features and outlines that share a commonality and sincerity. Later, around the 1400s, these features and outlines took shape in a more elaborate form. That was recognized as a popular architectural style at that time. This magnificent structure of the Sultanate period is a mosque with a dome. It can be said that during the Sultanate period, mosques with a single dome were in vogue. This did not develop so much later. However, structurally it is a miniature square mosque. Whose length and breadth are equal? The length of one side of this square mosque is 36 feet-2 inches on the outside and only 18 feet on the inside which is called the sanctum of the mosque. [16] The thickness of the walls of the mosque is 6 feet 4 inches.

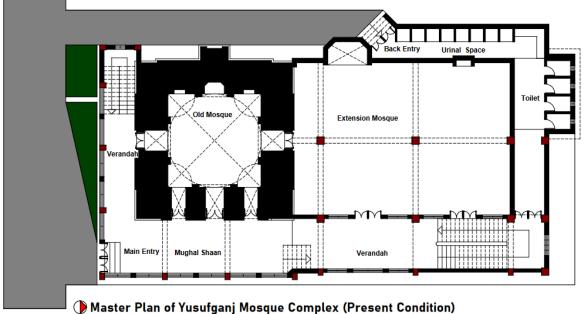
Fig.07 Master Plan of Ancient Yusufganj Mosque (Present Condition), Drawing by 1st Author.

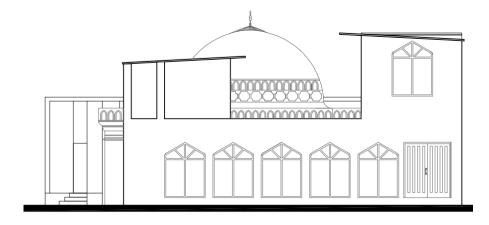
ENTRY ELEVATION OF YOUSUFGANJ MOSQUE 2024 [PRESENT CONDITION]
Fig.09 Present Elevation of Yusufganj Mosque, Drawing by 3rd Authors

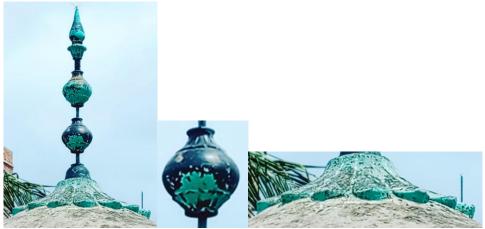
Fig.14 Mosque Shows Kalas-chura on the Top of the Dome, Photos by, 1st Author

On the outside of the dome, the presence of a lotus is seen at the apex. This lotus is again inverted and very mid-conjunct oriented. From the outside, it looks like a round flower arrangement. At the center of this asra is a pitcher. During the Sultanate period, the presence of such urns was seen in many mosques. It is basically a motif special. This pinnacle was determined by placing one pitcher on top of the other, either big or small. [20] Discussion, the existence of two kalas can be seen at the kalaschura of the mosque. Two pitchers are of the same size and supported on top of each other by an iron bar. A semicircular apple is present at the bottom. This is another pitcher fraction that looks like an apple. At the top of the pitcher is a piece of brass like arrowhead mounted and decorated.

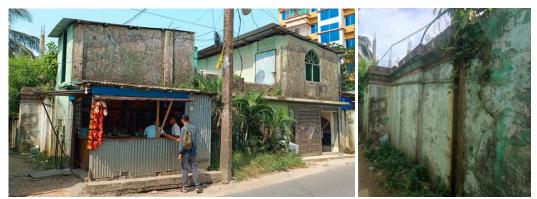
Fig. 18 Present Condition of Yousufganj Mosque, It's Effects, Building Materials. Photos by, Author.

Discussion, the mosque is square and has a dome. In the rectangular mosque, there are smaller domes next to the main dome. Although the four torrents around the mosque are a notable feature of the Sultanate period, this is not the case in the Yusufganj mosque. The mihrab and pulpit of the mosque are very simple. Clearly, it appears that there was a spirit of artistic carving which is absent today. The presence of terracotta is not seen on the outer walls, but some floral, vine-leaves and geometric designs can be seen on the inner walls. The arch that leads to the three-way entrance has wooden doors. These doors are basically the Louvre doors of the classical period. The inscription above the door is missing. Yusufganj Masjid has no windows, no minaret but had a courtyard which was later used as a balcony. It can be said that the use of essential colors in the mosque during this period has made the architecture and decoration style of the mosque visible.

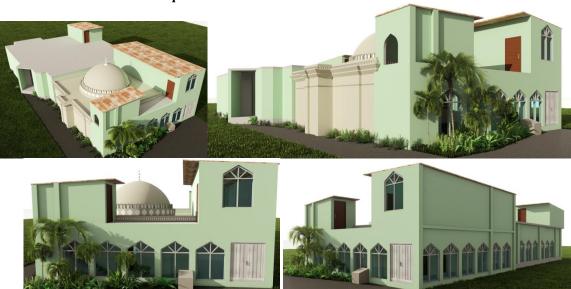
Fig. 20 Present 3D View of Overall Yusufganj Mosque Complex, 3D Modeling by, 3rd Author
