## Study of Landslide Occurance around Teluk Bajau, Ampera Street, Samarinda Seberang Sub District Based On Drone Aerial Photo Analysis and Field Analysis

Djumansi Derita, M. Taufan Tirkaamiana, Isnan Ismail A, Ismail, Jumani

Forestry Study Program, Faculty of Agriculture  
University of 17 Agustus 1945 Samarinda

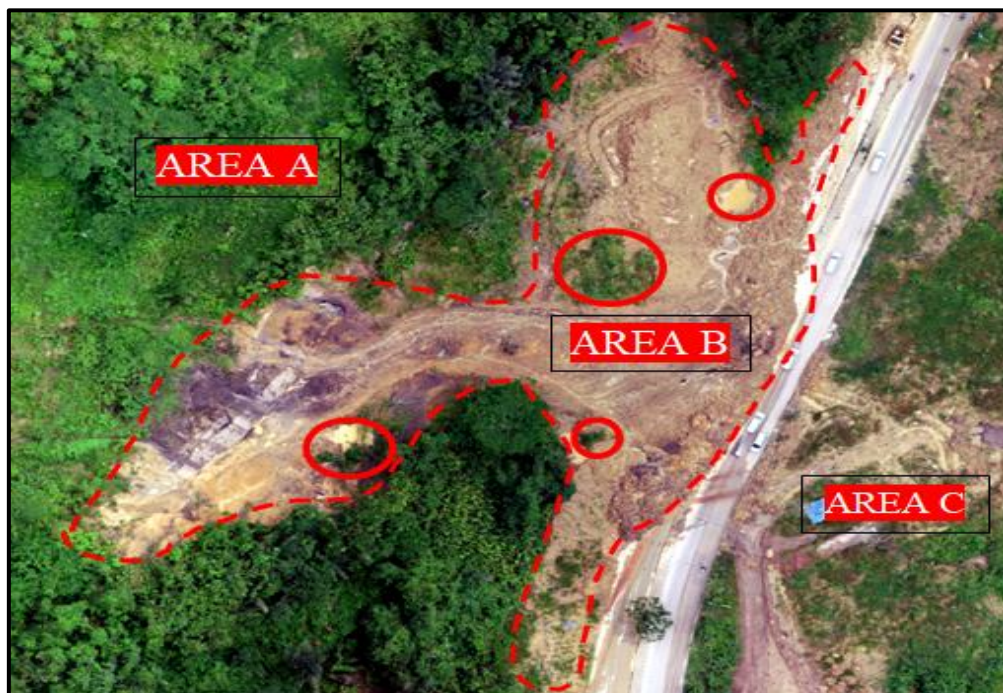
Figure 1. Landslide Zone Division in the Ampera Street Teluk Bajau Area

The landslide area zone is divided into three landslide zones, in zone A there is vegetation with low density or which is more dominated by shrubs. The slope in area A is still relatively steep compared to other zones. Zone area B is the part of the landslide that is affected, it can be seen in the area B zone image that there are characteristics of irregular vegetation growth, this also indicates that the landslide that occurred was quite large and deep. Zone C area is an open land that used to be a coal mine, and blackish soil can still be seen indicating the former coal excavation. The area is only overgrown with thin shrubs and grass, plus there is no conservation treatment yet.

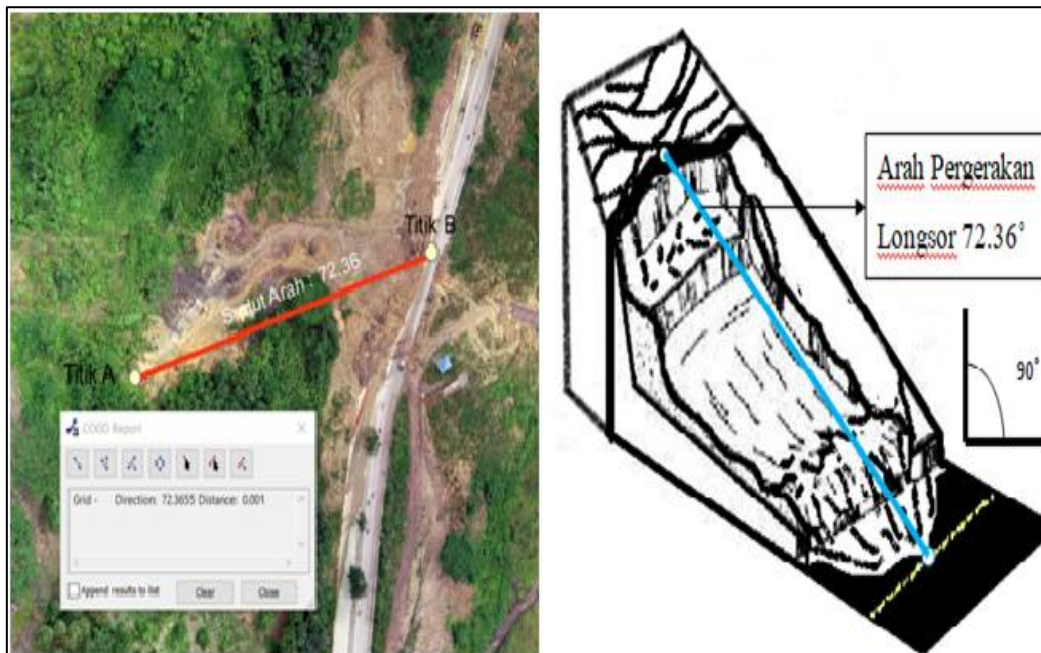
Figure 3. Landslide movement direction

The direction of landslide movement is the direction of the landslide that starts from the highest point on the cliff section of the landslide. The direction of landslide movement is written in units of direction angle, identified in landslides that occur in the direction of landslide movement towards 72.36°, or if you look at the picture the landslide image moves towards the main road.

The direction of landslide movement is identified using the COGO tools in the ArcMap application by providing two points, namely the initial highest point of the landslide section and the end point of the ground movement, then given a straight line transect connecting the two lines. If analyzed with orthomosaic image zoom, it will be seen that the landslide movement follows the groove formed by water flowing from the top of the slope.

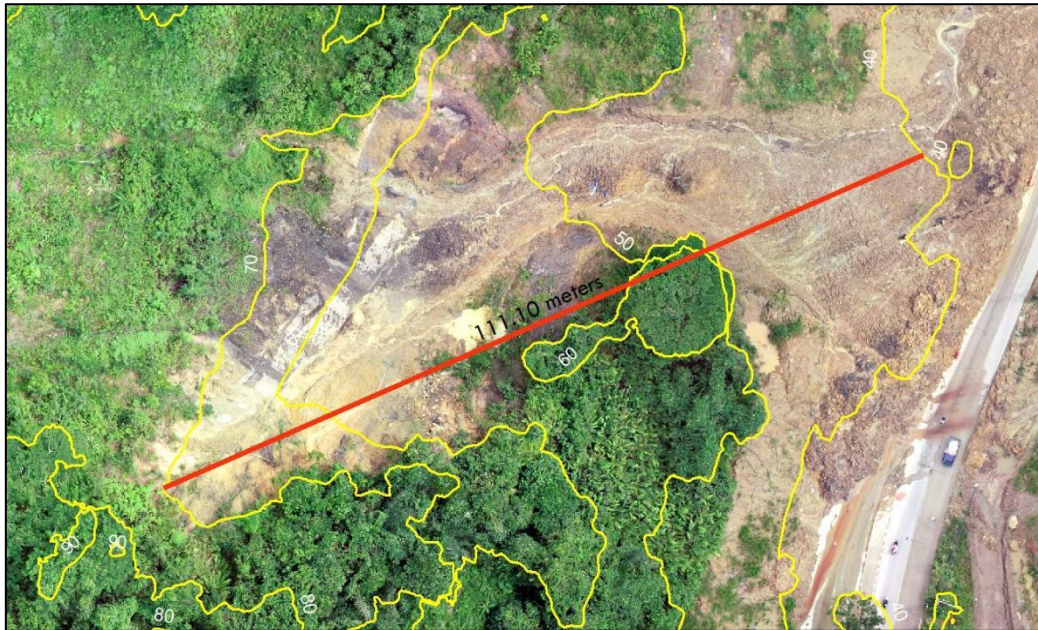
Figure 4. Flat Distance from Landslide Head to Landslide Foot

The height difference value is obtained from the upper slope value of 70 and the lower slope value of 40 which means the height difference is 30. For the flat distance value, it is known from the calculation results in the ArcMap calculate geometry, which is 110.10 meters.

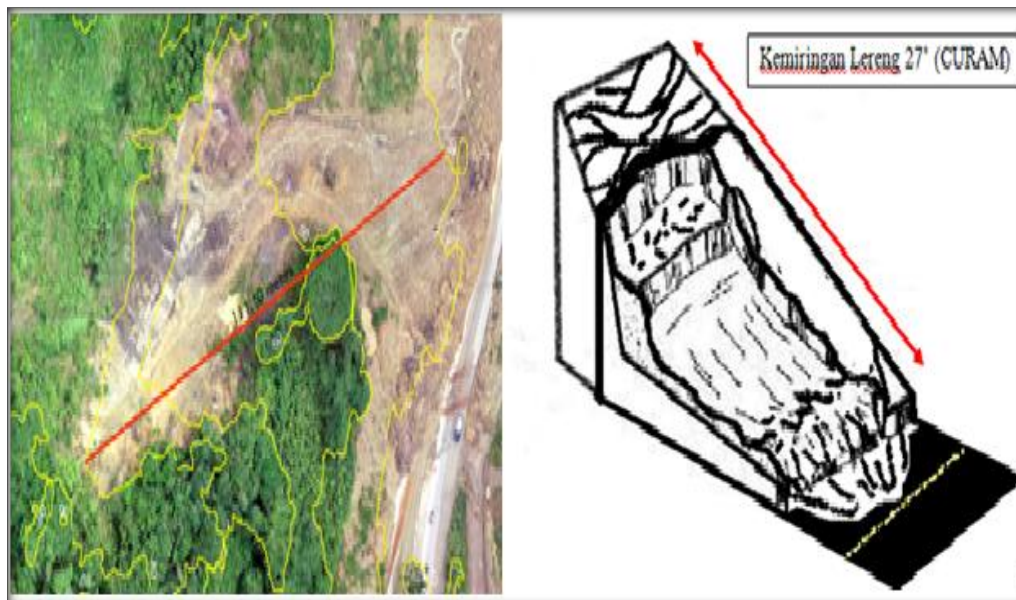
Figure 5. Slope Area

The slope in the landslide area of 27% is classified as steep in the range of 25-45%. The slope of this slope is the slope that is calculated only in the landslide area, the results of this slope will be related to the calculation of the depth of the landslide in that area. The picture shows the results of calculate geometry getting the results of a flat distance and the picture shows a sketch of the calculated slope.

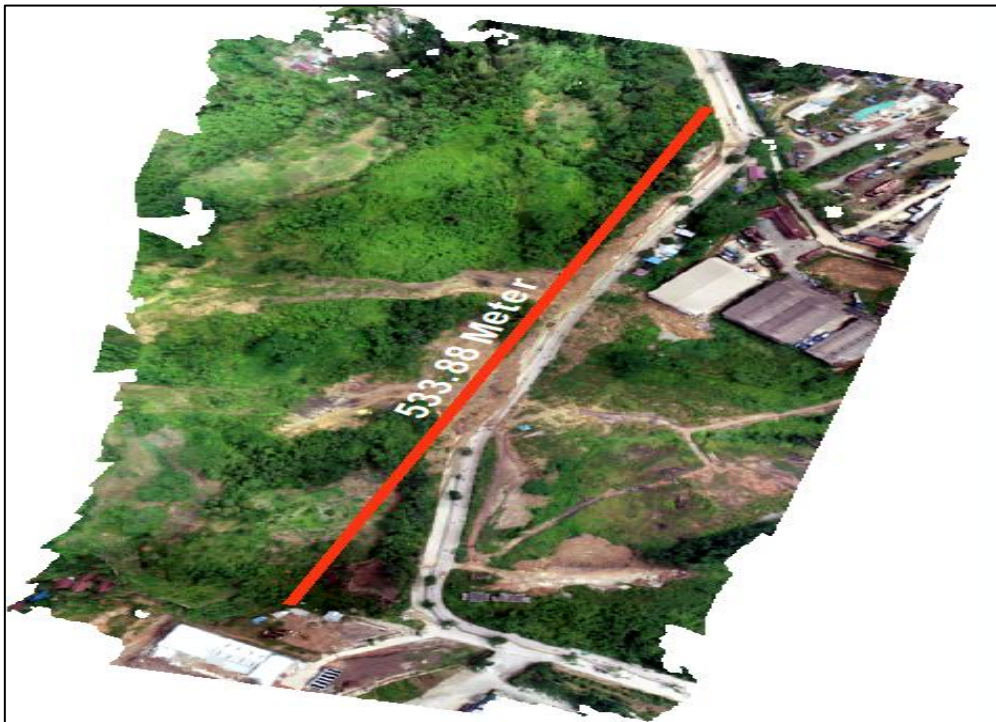
Figure 6. The length of the slopes of Ampera street

The length of the slope is closely related to the slope, the longer the slope with a steep slope, the potential for landslides around the area will be more prone to landslides. It is identified that the length of the slope in the landslide area is 533.88 meters or if it is converted to 0.534 kilometers. The length of the slope of the landslide

area is classified as very long, the range is >500 meters and the dominant shape is concave because it is a lot of hilly.

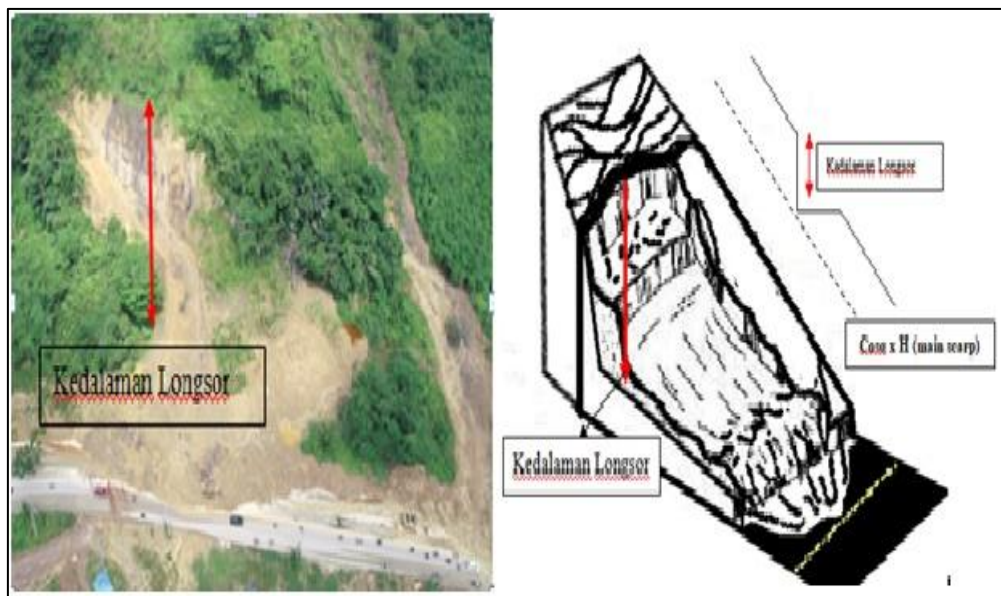
Figure 8. Estimation of landslide depth

It was identified that the estimated depth of the landslide was 13.79 meters. If you look at the landslide depth classification table, the landslide in this area is included in the deep landslide class where the range of deep landslides is 5 – 20 meters.

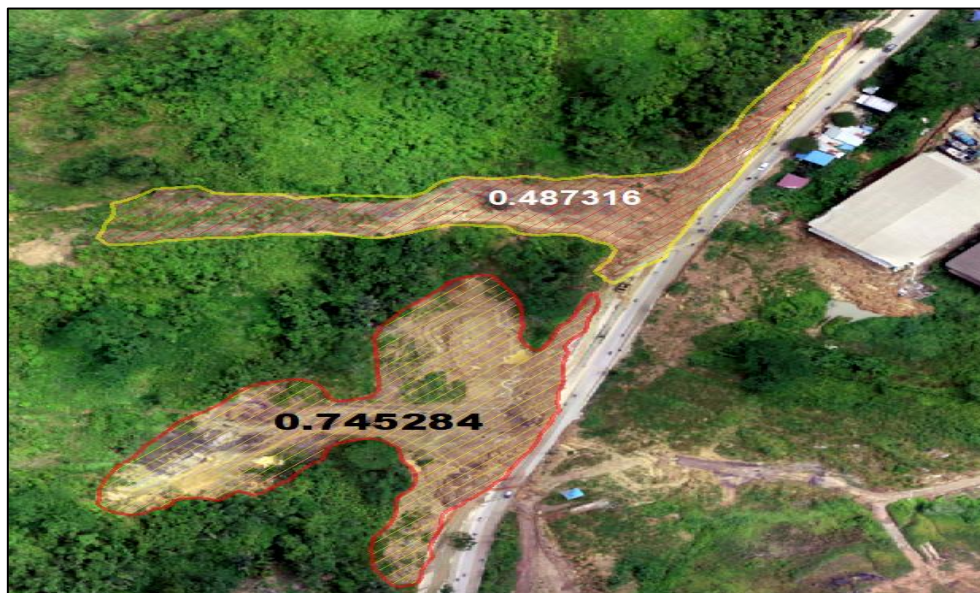
Figure 10. Area of Identified Landslide (Main Landslide and Landslide Affected)

The landslide area in the research area is 0.745284 hectares. The area of landslides is expected to continue to increase considering that the monthly rainfall is still relatively moderate in the Samarinda City area. If there is heavy rain, the landslide area will continue to experience landslides that cover the main road which results in road cuts. Identify the landslide area using closed polygon digitization and then activate calculate geometry in the open attribute table.

If viewed from the aerial photo analysis, the landslide area extended to the northern part of the main landslide, precisely at the coordinates of UTM X 117.1505028 and Y -0.533586228 at an altitude of 64.08 meters. Landslide can be seen that follow the flow of water on the surface or form like rill erosion.

The area of the landslide affected by the main landslide was 0.487316 Ha, including wide coverage because the affected area was still on the same slope path as the main landslide. If the affected landslide continues to spread, it is possible that the cliff edge of the slope will also slide too.

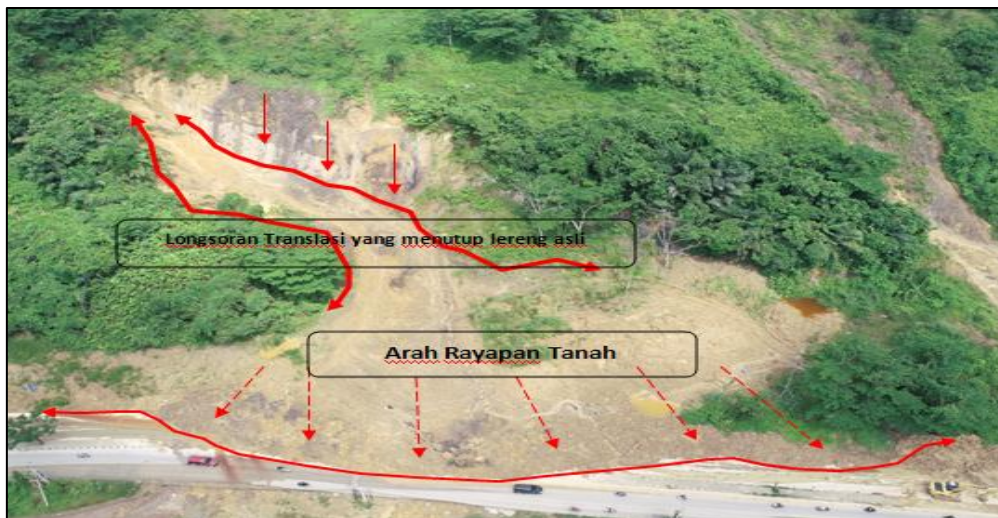
Figure 11. Identification Type :slide that occurs

In the photo, the landslide condition looks more detailed, starting from the soil layer to the damage to the vegetation that occurred in the area affected by the landslide. The main scar on the top of the landslide that is

visible indicates that the landslide that occurred was a deep landslide, and the hillside was slowly being eroded by the flow of water that formed on the landslide body. The overflow of landslides also consumed the main one-lane road leading to Samarinda Seberang from the direction of Palaran sub-District.

The results of the analysis of the types of landslides that occur in the Ampera street landslide are translational landslides and soil creep. It is called a translational avalanche because the landslide part in the form of soil and rock forms high waves that cover the original soil on that part of the slope, then it is also called soil creep because slowly the landslide impulse when it rains takes up part of the road and the median of the road which causes some road infrastructure to become damaged. damaged.

The soil creep is in the form of coarse soil, clay loam, and small to medium sized rocks. If you look at the soil type map that has been made, this area has Ultisols or the composition of the soil-forming is more clay than sand and dust, it can also be estimated that the soil will be slower to absorb water when it rains as a result, a lot of water flow is formed in the landslide body.

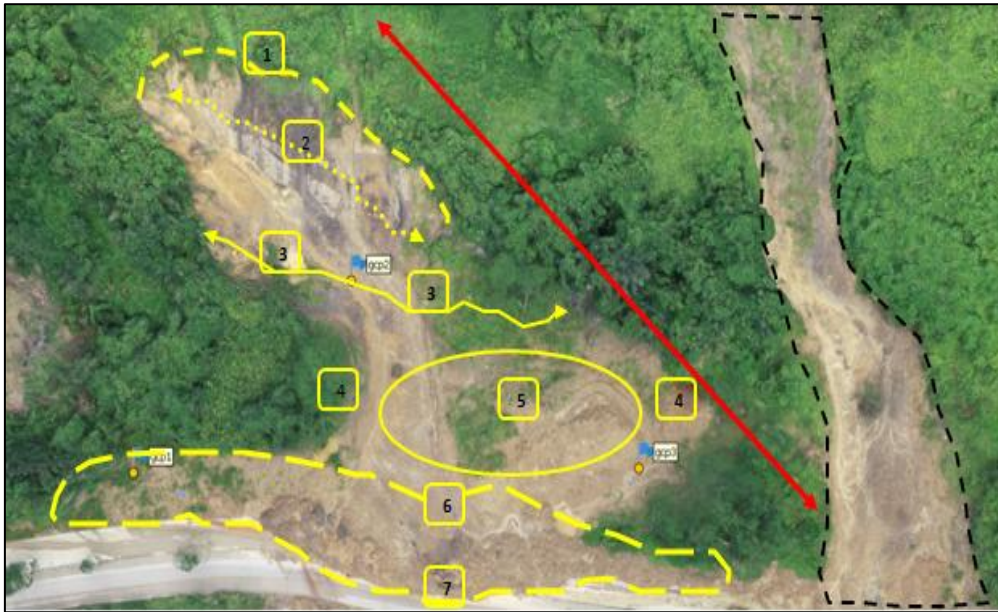
Figure 12. Identified Landslide Section on 3D Photo

Through 3D (3 Dimensional) photos, all parts of the landslide that occurred in the research area were identified. It can be seen in the picture, the area numbered 1 is the head scarp, section number 2 is the main scarp (main cliff), section number 3 is the peak that collapsed, section number 4 is the outermost side of the landslide body, section number 5 is the landslide body (the main part of the landslide), part number 6 is the foot of the landslide and part number 7 is the tip of the landslide.

The identified size is part number 2 (main scarp), and overall the landslide area is identified. In the section bordered by the black line is the area affected by the identified main landslide, this section was formed due to the flow of water coming from the top of the slope. If you look at all parts of the landslide, it can be estimated that the flow of water flowing over the slope is quite heavy so that it gradually erodes the soil so that the occurrence of soil creep. It can also be estimated that the water does not flow in its path because there is no conservation treatment on the slopes where landslides occur.

1. It is recommended that when determining the GCP (Ground Control Point) point it is done at the end of the boundaries of the research area and in an open area that can be clearly seen because when the photo is taken, the 3D drone will be recorded from all directions.
2. For landslide events, in order to minimize soil creep that continues to occur, it is possible to take soil and water conservation actions gradually.
3. For vegetative action in the landslide area or along the slope of the landslide area, planting plants or slope-reinforcing stands, for example, can be Bamboo Trees, Breadfruit Trees, Mahogany Trees, and Fragrant Roots, then ensure that all land cover in the slope area has a minimum vegetation density of moderate to moderate tall.
