Static Balancing of Centrifugal Fan

Ekpenyong Ekpenyong Ekpo¹, Samuel Audu Seth², Kelas David Kario³, Nasir Muhammad Yelma⁴

^{1,2}(Maintenance Department, Ashaka cem, Lafarge Africa plc)

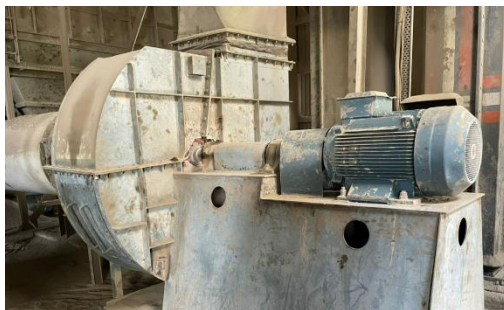
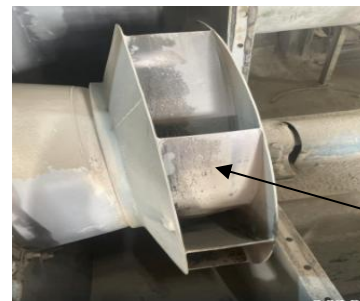
Figure 2: centrifugal fan

- (i) The machine in question is a 9-blade industrial fan (centrifugal fan) running at 1475 RPM and mounted rigidly as shown in figure 2.

Fan blade

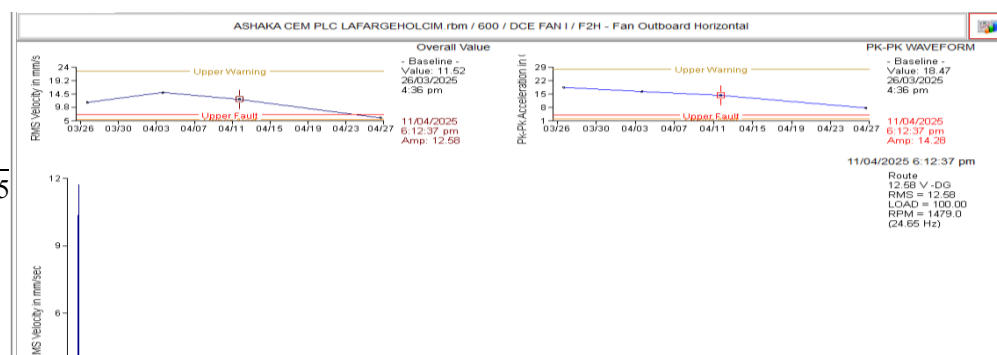
From the initial diagnosis, several critical mechanical faults were identified and addressed. These included an impeller shaft misalignment, which was contributing significantly to axial vibration (figure 4c), a bearing housing mismatch, and casing distortion (cracks). These issues were corrected through detailed inspection and reassembly, followed by alignment of the motor and fan shafts. The alignment process aimed to minimize angular and parallel offset between the rotating components, thereby reducing the stress on bearings and shafts. The vibration reading obtained was recorded in table 2 and the wave front in figure 5.

While the mechanical corrections and shaft alignment provided some relief, leading to a slight reduction in vibration amplitudes (e.g., horizontal vibration at FDE decreased from 17.38 mm/sec to 12.48 mm/sec, a 25.4 % reduction), the overall vibration levels remained considerably high and above ISO acceptable limits as shown on the wave fronts (figure 5a – 5f), confirming that correcting shaft misalignment was effective. However, the dominant 1X component remained, and overall amplitudes, especially in the horizontal direction, stayed high. This signaled persistent unbalance on the impeller, reinforcing the need for balancing, which the alignment process alone could not fully address.

Figure 5a: Fan Drive End (FDE) – Horizontal vibration wave front

Figure 5b: Fan Drive End (FDE) – Vertical vibration wave front

Figure 5c: Fan Drive End (FDE) – Axial vibration wave front

Figure 5d: Fan Non-Drive End (FNDE) – Horizontal vibration wave front

Figure 5e: Fan Non-Drive End (FNDE) – Vertical vibration wave front

Figure 5f: Fan Non-Drive End (FNDE) – Axial vibration wave front

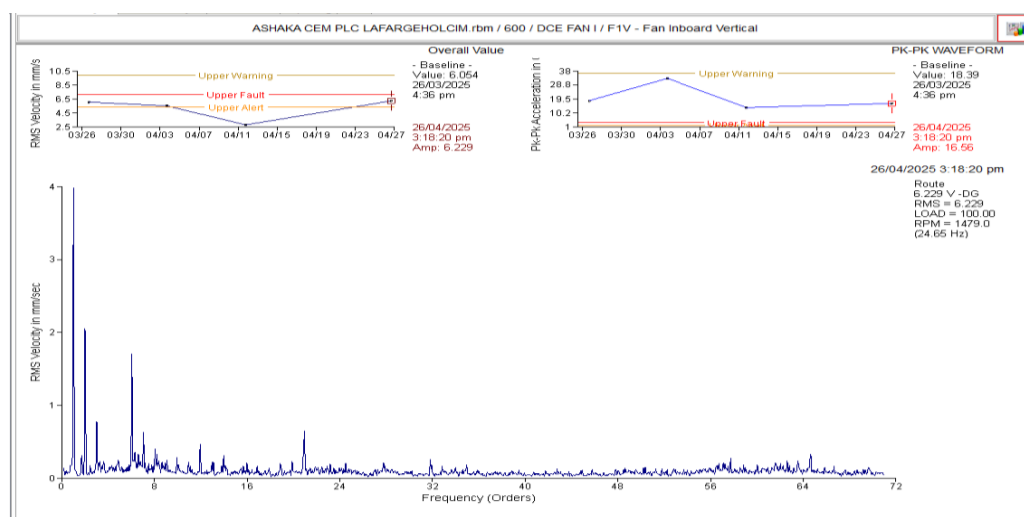
After applying the 20 g trial weight, the wave fronts showed a dramatic reduction in amplitude across all measurement points, particularly at FNDE. For instance, the horizontal vibration at FNDE was reduced from 12.58 mm/sec to 6.04 mm/sec, representing a 51 % reduction from the post-alignment state, confirming the effectiveness of the trial weight in mitigating the primary unbalance force as shown below. While the improvement was most pronounced in the horizontal plane (as expected for static unbalance), notable reductions were also observed in vertical and axial directions, indicating a more stable overall rotational system.

Figure 6a: Fan Drive End (FDE) – Horizontal vibration wave front

Figure 6b: Fan Drive End (FDE) – Vertical vibration wave front

Figure 6d: Fan Non-Drive End (FNDE) – Horizontal vibration wave front

Figure 6e: Fan Non-Drive End (FNDE) – Vertical vibration wave front.

Figure 6f: Fan Non-Drive End (FNDE) – Axial vibration wave front

A sequence of trial weights was tested for static correction. 5 g weight at 12 o' clock showed minimal effect. 17 g improved the settling balance but not satisfactorily. 20 g weight demonstrated the most significant correction during manual settling. The 20 g trial weight was mounted at 12 o' clock and the fan were reassembled for operational testing. Upon startup, the new vibration profile was measured across all four bearing locations using the SKF Quick Collect CMDT391 sensor and later confirmed with the CSI 2140 analyzer.
