# A Comparison of Existing Value with the Remedial Workproject Value of a Dam in Reducing the Risk of Dam Failure At Tolotangga Dam Of Bima Regency In West Nusa Tenggara Province

**ABSTRACT :** This research was conducted at Tolotangga Dam in Tolo Uwi Village, Monta district, of Bima Regency. Body of the dam is built on tuff sandstone where the tuff sandstone section still maintained resulted in clear water leakage found in the downstream part of the dam. Construction of the dam aims to ensure water availability to support and fulfill necessities according to the existing demand around the dam location, such as: (1) for irrigation purpose, (2) fulfillment of raw water needs, and (3) for electricity generator, etc.

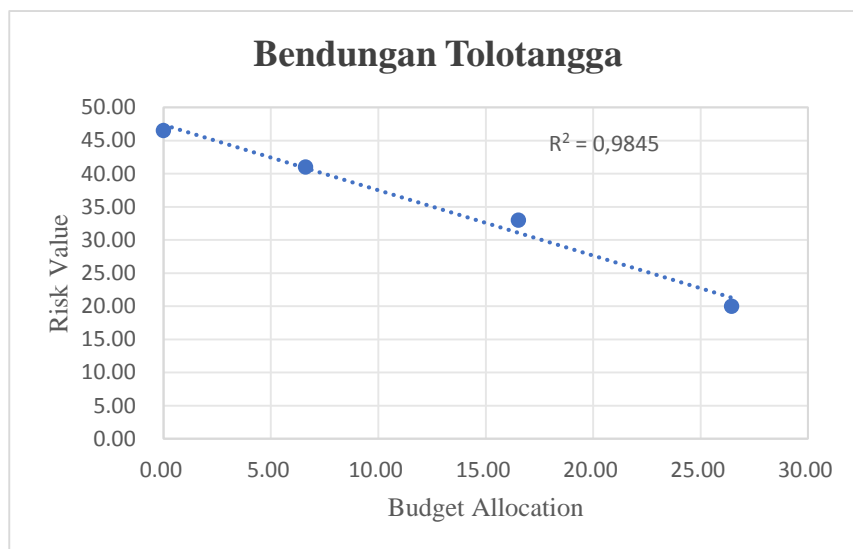
**Figure 2:** Budget allocation graph

From the graph is evident that budget allocation treated with RWP work has a positive impact on reducing risk with a deterministic value of 0.9845.

No	Risk Index	Risk Assessment			
		Existing	RWP - 60%	RWP	Max
1	Reservoir storage capacity	2	2	2	2
2	Data of the dam	3	3	3	3
3	Deficiency related to evacuation	12	9	5	1
4	Potential of downstream damage to the existing structure	8	8	8	8
5	Historical recording of construction and maintenance	3	3	3	0
6	Instrumentation deficiency	3	2	1	0
7	Previous level of the safety efforts	3	3	2	0
8	Development plan at downstream area	2,5	2	1	0
9	Flood deficiency	2	2	2	2
10	Static stability deficiency	4	3	2	0
11	Earthquake resistance deficiency	4	4	4	4
<b>Amount</b>		<b>46,5</b>	<b>41,0</b>	<b>33,0</b>	<b>20,0</b>
<b>Class of Risk</b>		<b>High</b>	<b>Mode rate</b>	<b>Mode rate</b>	<b>Mode rate</b>
