## Water Resources Potential of Kirklareli Province in Turkey

Nilufer YAZICI<sup>1</sup>

<sup>1</sup>(Isparta University of Applied Sciences Faculty of Forestry Departments of Forest Engineering  
Isparta/TURKEY)

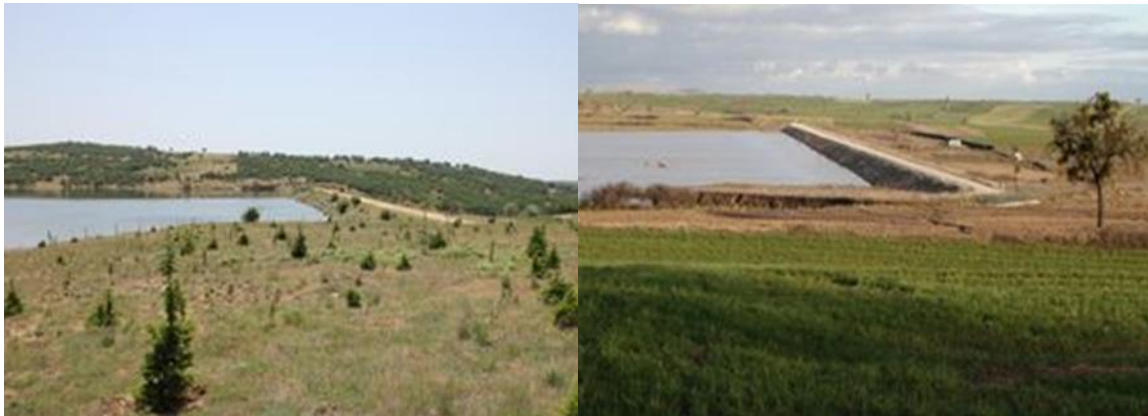
Figure 1. Central Üsküp (left) and Central Dolhan (right) Ponds [7]

**Central Üsküp Pond:** It was located 3 km northeast of the Skopje District of Kırklareli central district (Figure 1). Its source is Skopje stream. It was built between 1987-1990 for demanding of irrigation and drinking water supply. Zoned soil filling, storage volume  $1.24 \text{ hm}^3$  active volumes  $1.06 \text{ hm}^3$ , dead volume  $0.18 \text{ hm}^3$  height 22 m from the river bed. The lake provided 166 hectares of irrigation area and  $0.05 \text{ hm}^3$  / year drinking water [10].

**Central Dolhan Pond:** It was located in the north of Dolhan village in the central district of Kırklareli province (Figure 1). Cihanlar Stream was fed by the stream. It was built between 1999-2005 for irrigation purposes. Zoned soil filling, storage volume  $1.09 \text{ hm}^3$  active volumes  $0.93 \text{ hm}^3$ , dead volume  $0.16 \text{ hm}^3$  height 22.5 m from the stream bed. The lake provided 172 hectares of irrigation area [10].

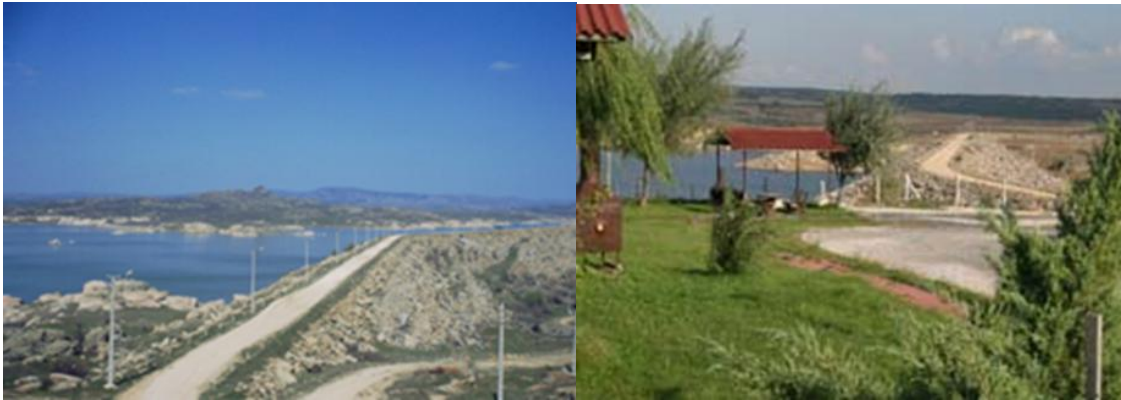
Figure 2. Kayalıköy (left) and Kırklareli (right) Dams [7]

**Kayalıköy Dam:** It was built between 1975 and 1986 for the purpose of irrigation, flood control and drinking water, 14 km northwest of Kırklareli province (Figure 2). The body volume of the dam, which was the soil and rock body filling type, was 68.7 m in height from the river bed of  $1.53 \text{ hm}^3$ , the lake volume in the normal water level was  $149.86 \text{ hm}^3$  and the lake in the normal water level was  $101.86 \text{ km}^2$ . While the dam provided irrigation purpose in agricultural land an area of 15,957 hectares, it supplied  $5,96 \text{ hm}^3$  / year drinking water annually to Edirne province and  $0,49 \text{ hm}^3$ /year drinkable water to Kırklareli province [6].

**Kırklareli Dam:** It was constructed in Kırklareli on Şeytandere for the purpose of irrigation, flood control, drinking water and industrial water between 1985-1997 (Figure 2). The body volume of the dam, which was the soil and rock body filling type, was 67.5 m in height from the river bed of  $1.46 \text{ hm}^3$ , the lake volume in normal water level was  $113.31 \text{ hm}^3$ , and the lake area in normal water level was  $5.98 \text{ km}^2$ . The dam provided irrigation services to an area of 13,679 hectares, while it provided  $10,70 \text{ hm}^3$  / year of potable water annually [10].

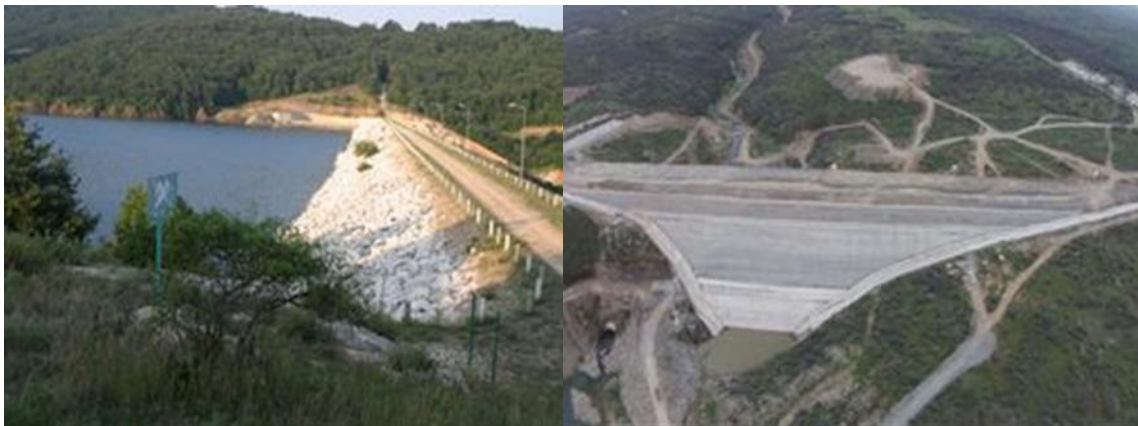
Figure 3. Armağan (left) and Çayırdere (right) Dams [7]

Armağan Dam: The dam was built between 1986 and 1998 for irrigation purposes in the northeast of Armağan Village of Kırklareli province (Figure 3). The body volume of the dam, which was the clay core and rock filling type, was 57.5 m in height from the river bed of 1.50 hm<sup>3</sup>, the lake volume in the normal water level was 51.50 hm<sup>3</sup> and the lake in the normal water level was 3.05 km<sup>2</sup>. The dam provided irrigation services to an area of 590 hectares [10].

Çayırdere Dam: Feeding from Kocadere stream 2.5 km northeast of Çayırdere village of Pınarhisar district of Kırklareli province, construction started in 2011 for irrigation and was completed at the end of 2015 (Figure 3). The front was covered with concrete, the rock volume was 0,609 hm<sup>3</sup> and its height was 58,50 m from the stream bed, the lake volume was 28,25 hm<sup>3</sup> in normal water level and its lake in the normal water level was 2,02 km<sup>2</sup>. The dam would supply irrigation demand to an area of 2,583 hectares. Body filling had reached the level of +320,00 [10].

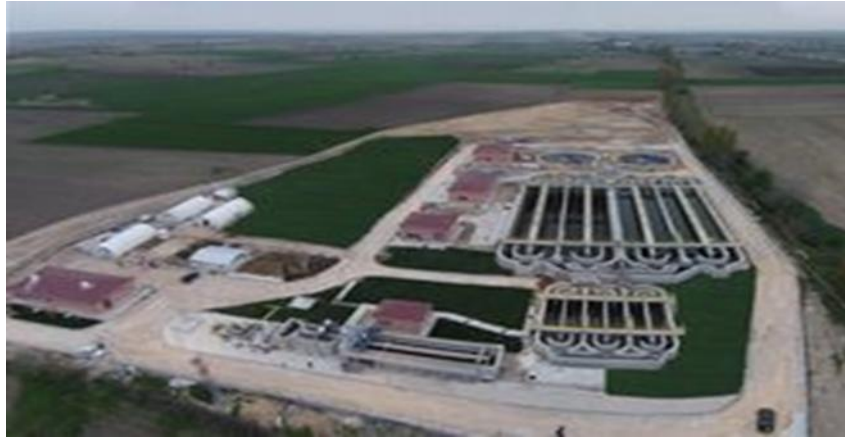
**Figure 4. Kırklareli Municipality domestic wastewater treatment plant [6]**

It was located in the city center of Kırklareli. Domestic waste water of Kırklareli Municipality would be discharged after advanced biological treatment. Its construction was completed between 2013 and 2014 (Figure 4). The normal capacity of the facility was 1<sup>st</sup> Floor: 13.398 m<sup>3</sup>/day, Second Level: 17.268 m<sup>3</sup>/day. It had two coarse and fine grills, 2 aerated sand and oil traps, 3 anaerobic pools, 6 aeration pools, 3 sedimentation pools. The flow rate of Kırklareli (central) potable water Treatment Plant was given as 25,920 m<sup>3</sup> / day (300 l/s) by the provincial bank. The purified water quality in this facility complies with WHO and EEC standards [10].

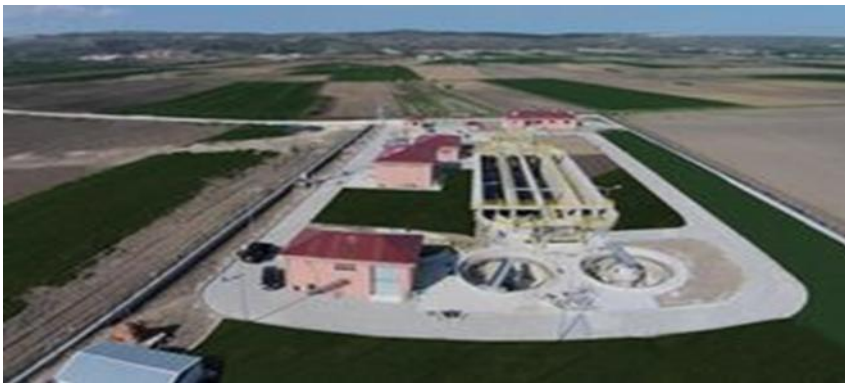
**Figure 5. Vize Municipality domestic wastewater treatment plant [6]**

It was located in Vize district of Kırklareli province. It was built between 2013 and 2014 in order to ensure the discharge of domestic waste water of Kırklareli Vize Municipality after advanced biological treatment (Figure 5). The normal capacity of the facility was 1<sup>st</sup> floor: 2,690 m<sup>3</sup>/day, second level: 3,802 m<sup>3</sup> / day. It had two coarse and fine grills, 2 aerated sand and oil traps, 3 anaerobic pools, 2 aeration pools, 2 sedimentation pools. Board acceptance was completed on 30.05.2014 and it is at the commissioning stage [6].

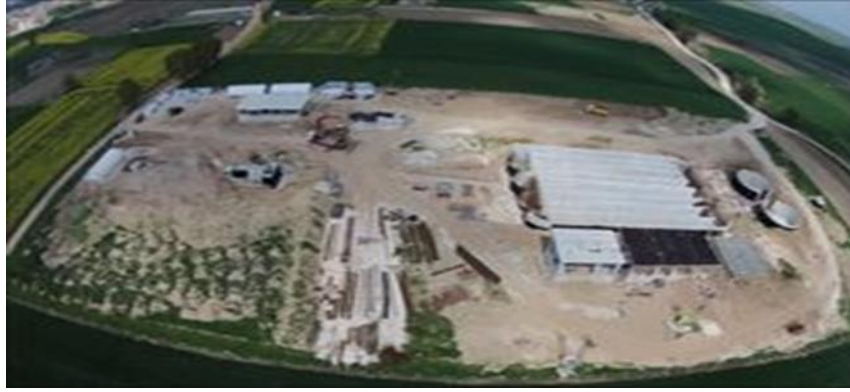
Figure 6. Babaeski Municipality waste water treatment plant [6]

The plant was located in Babaeski district of Kırklareli province. It was built between 2013 and 2014 in order to ensure the discharge of domestic waste water of Kırklareli Babaeski Municipality after advanced biological treatment (Figure 6). The normal capacity of the facility is 1<sup>st</sup> floor: 5,266 m<sup>3</sup>/day, second level: 6,651 m<sup>3</sup>/day. It had two coarse and fine grills, 2 aerated sand and oil traps, 3 anaerobic pools, 4 aeration pools, 2 sedimentation pools. Reinforced concrete construction of the ventilation pool and other buildings was ongoing [6].

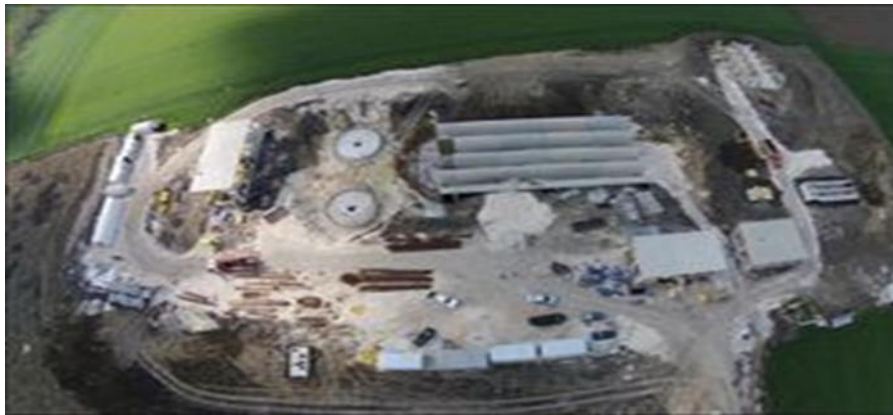
Figure 7. Pınarhisar Municipality waste water treatment plant [6]

The plant built between 2013 and 2014 was located in Pınarhisar district of Kırklareli province in order to discharge the domestic waste water of Kırklareli Pınarhisar Municipality after advanced biological treatment (Figure 7). The normal capacity of the facility was 1<sup>st</sup> floor: 2,050 m<sup>3</sup>/day, second level: 2,789 m<sup>3</sup>/day. It had two coarse and fine grills, 2 aerated sand and oil traps, 3 anaerobic pools, 2 aeration pools, 2 sedimentation pools. Reinforced concrete construction of the ventilation pool and other buildings was ongoing [6].
