Post caesarean section wound gaping: Discussing the problem and treatment options

ABSTRACT: Wound gaping in post operative patients of caesarean section increases morbidity and hospital stay of the patient. It can be dealt with secondary wound closure, mobilisation of local tissue to cover the wound or the raw area can be covered with split thickness skin graft or flap. We present different treatment aspects for dealing with these wounds

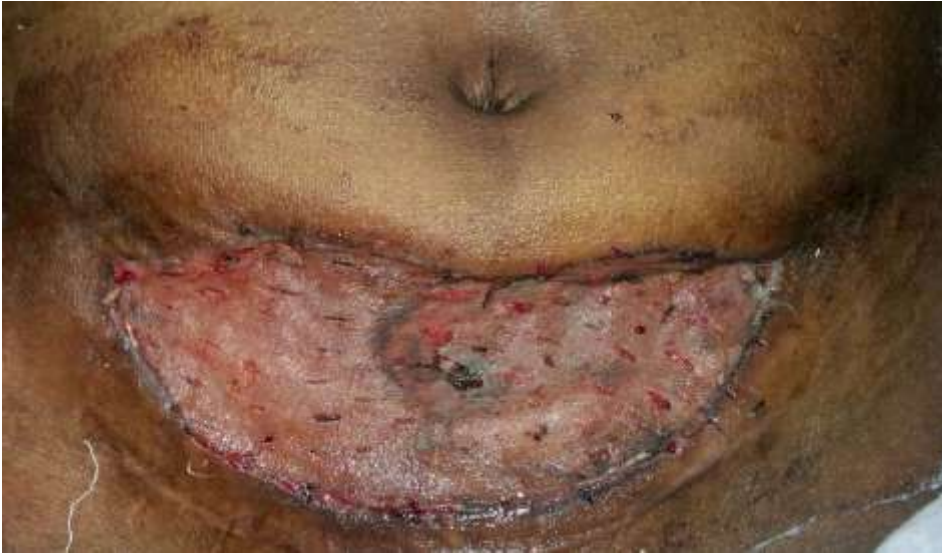
Figure 1- Post operative photograph of case 5

Case 5: 24 year female presented with post LSCS wound gaping 18 days after surgery. Examination revealed that the patient was anaemic. There was a 14x8cm raw area over anterior abdominal wall. Negative pressure wound therapy and correction of anaemia was advised and once the wound granulation improved and anaemia corrected, the raw area was covered with split thickness skin graft. There was small amount of graft loss which healed by epithelisation. Patient was discharged on 10th postoperative day.

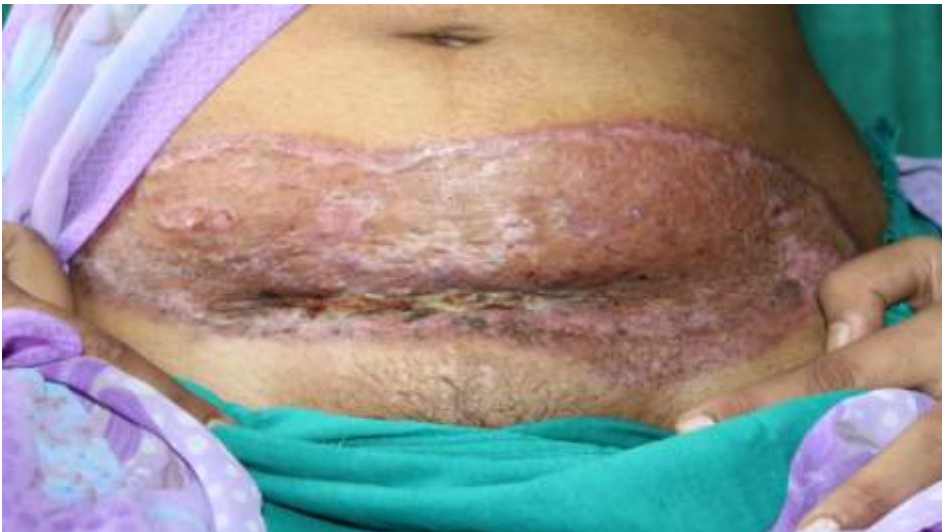
Figure 2- Post operative photograph of case 3

Case 3: 25 year female patient was referred for post L.S.C.S. wound gaping and presacral bed sore. She developed wound gaping after 7th postoperative day and presacral sore after 12 days of intensive care for uncontrolled hypertension in postpartum period. Examination revealed 8.5x3cm wound on anterior abdominal wall and a grade 4 presacral sore of size 11x9.5cm in horizontal and vertical extent. After anesthetic fitness, she underwent secondary closure of anterior abdominal wall wound and debridement and negative suction wound therapy for presacral wound. After 10 days of therapy there was improvement in granulation. Her anemia was corrected by blood transfusion. Raw area was covered with intermediate thickness skin grafting and patient was discharged 2 weeks after surgery. Graft uptake was almost 100%.

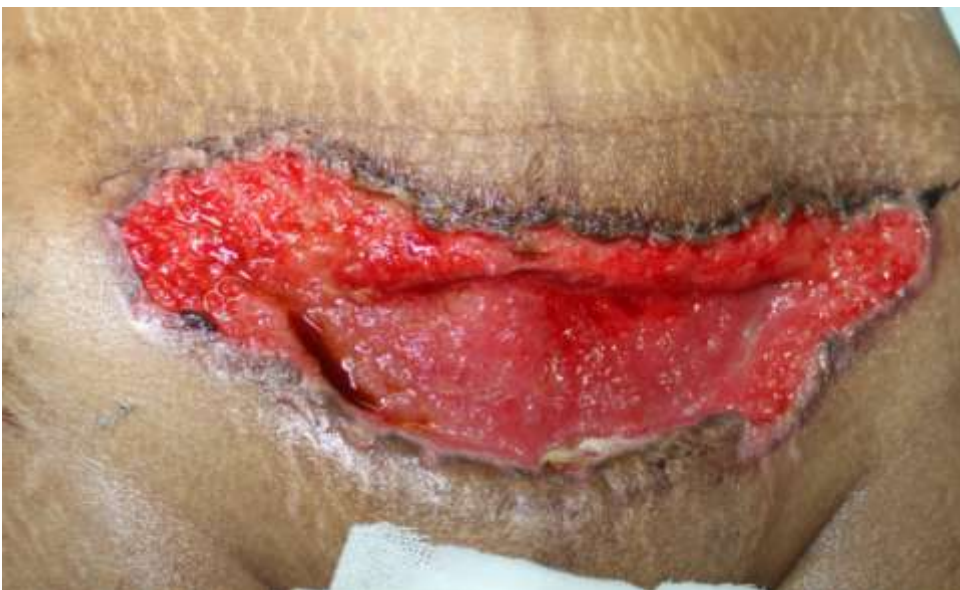
Figure 3- Pre operative photograph of case 1

Case1: A 22 year female was referred to us for wound dehiscence following lower segment caesarean section(L.S.C.S.). She had developed wound gaping 13 days after LSCS. Examination revealed a 12x8 cm wound in horizontal and vertical extent on anterior abdominal wall with unhealthy granulation tissue. Anaemia and hypoproteinemia was present. Patient was posted for surgery after anesthetic fitness and correction of anaemia and hypoproteinemia.. Slough and devitalised tissue were excised and the superior flap of the wound was raised in the fashion of the abdominoplasty. After sufficient mobilisation, the wound edges were brought closer to each other without tension and closed secondarily over a drain. She was kept with her knees flexed in post operative period. Drain was removed on the 3rd day and patient was discharged on 4th postoperative day with the advice to keep the knees flexed for 3 weeks. There was no wound gaping and sutures were removed after 2 weeks on followup.

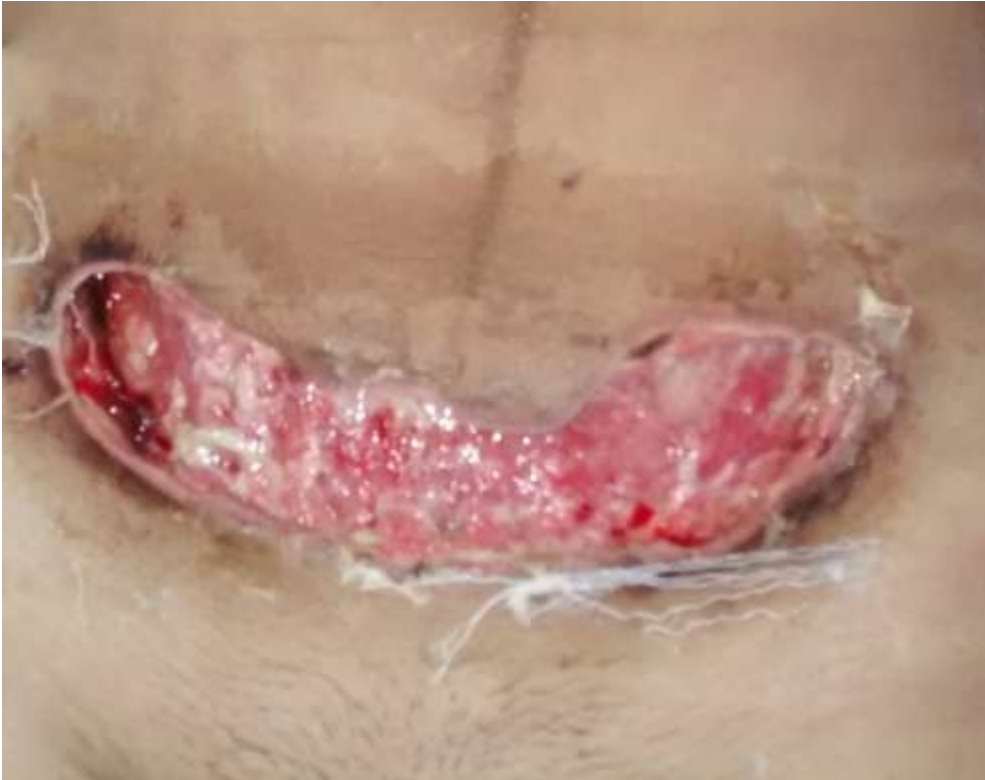
Figure 4- Pre operative photograph of case 4

Case 4: 25years female was referred to us following post LSCS wound dehiscence 2 weeks after the surgery. Examination revealed a 10.5x 6 cm wound over the Pfannenstiel incision. She was posted for surgery after anesthetic fitness and wound was closed secondarily after debridement over drain. Sutures were removed after 2 weeks. Post operative recovery was satisfactory without any complications.
